Sustainable Water Management in the University of Sonora, Mexico

**2nd. International Workshop
Advances in Cleaner Production**

Objective

The purpose of this article is to describe the effectiveness of the University of Sonora's Sustainability Management System (SMS) about water management, and provide more insights for enriching the actual debate about how to prevent, eliminated and reduce water use inefficiencies on campus.

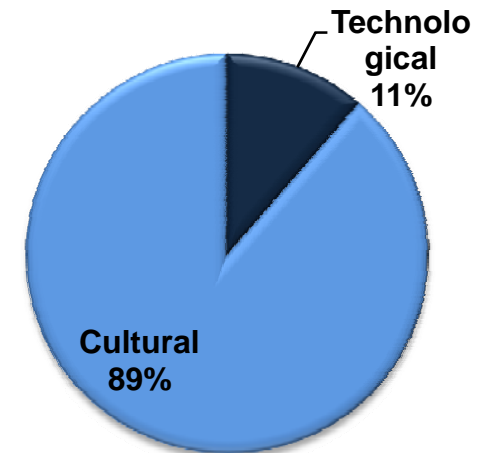
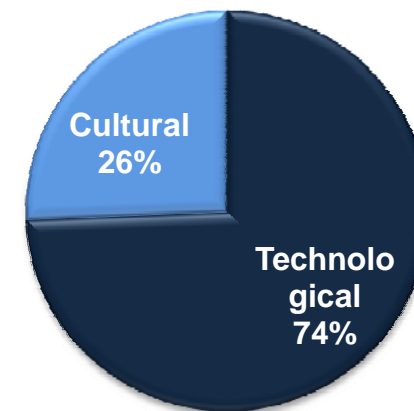
Cultural inefficiencies

Building	Frequency	
5F-LR	1	1
5M-MR	216	0
5K-MR	2	2
5K-LR	2	2
5O-LR	5	5
Cultural failures	226	10
Population	1645	
Population without compromise	13.74%	0.61%

MR= Men's room
LR= Ladies' room
